# MAJOR LEAKS!

You're about to leave the boat. As you remove the log impeller, the whole fitting comes away and water gushes in.

Chris Beeson finds out what to do next

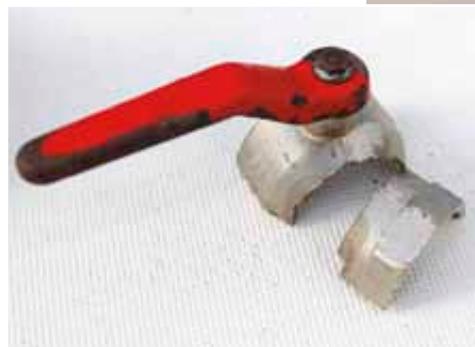
*TOP: This cheap ball valve simply disintegrated with corrosion.*

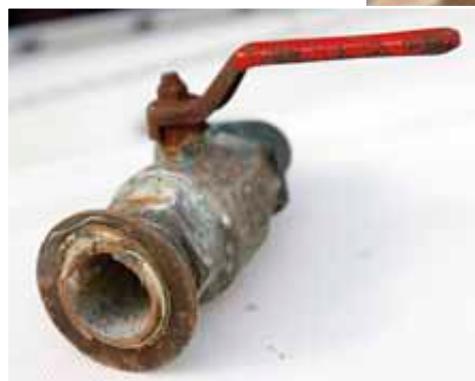
*ABOVE: Here we see a seacock that has sheared off at the hull, leaving a silently leaking hole*

Our consultant for this test was Paul Stevens, a marine surveyor with 20 years' experience and the whistleblower who inspired *YM's* Seacock Safety Campaign. He explained that seacocks have three failure modes. The most common is where a corroded pipe shears off at the hull, leaving nothing more than a hole. The second is when the ball valve cracks, leaving just the through-hull fitting. In the third failure scenario, the hose slips off the tail pipe inboard of the ball valve, or the corroded tail pipe

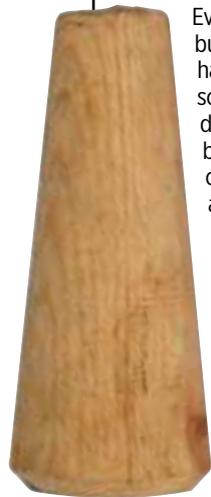
## Softwood bung

Everyone has wooden bungs aboard, or should have. It's an inexpensive solution to a potentially disastrous problem, but is it an effective one? The answer is yes, a bung works well. It's quick and easy to deploy, and has no moving parts or breakable elements. With an intact log through-hull pipe, it didn't need much force to insert and formed a perfect seal.

With a damaged pipe, insertion was just as easy but the seal was imperfect and a small fountain of water jetted out of the forward edge of the pipe.

you would need to pump the bilges two or three times an hour while you're preparing a more effective repair. I found the bung difficult to extract, as it was jammed against the rough lining of the pipe. With a fragile pipe, obviously you need to be gentle removing the bung to avoid making the problem worse.

*With a cracked tailpipe, the bung leaves a fairly serious leak*

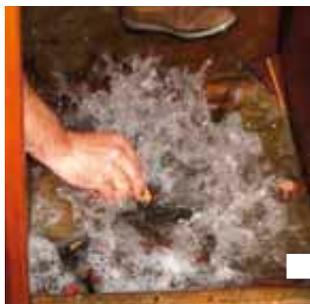
*The most common solution is cheap, simple and quick to deploy if a through-hull breaks*

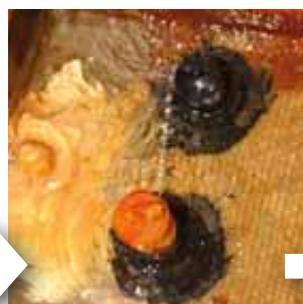
*It significantly reduces the leak but forms an imperfect seal if the tailpipe is cracked or deformed*

The bung was also effective with the seacock tail pipe, but noticeably less so. Paul pointed out that it's not rare for the tail pipe to break in the way ours did, distorting the pipe. The bung significantly reduced flooding but there was a steady stream of water pouring past the bung at the tear. Again, it would give you control of the situation but

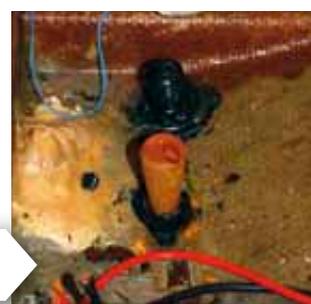
*With the fitting smashed away completely, leaving a round hole, the bung forms a perfect seal*

With the log through-hull pipe knocked off at hull level, the bung once again formed a perfect seal. However, there's no doubt that, in this scenario, the bung would give you control

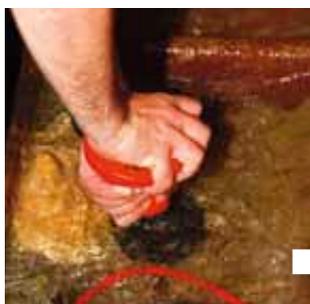
*The closed-cell foam TruPlug inserts using a squeezing, twisting and pushing action*

Rather than just plugging into the pipe, you are supposed to grip the cone with one hand, the base with the other, and twist it in. It formed a perfect seal with the damaged log pipe, stopping ingress completely. With the log pipe knocked out to hull level, it was also a perfect fit.

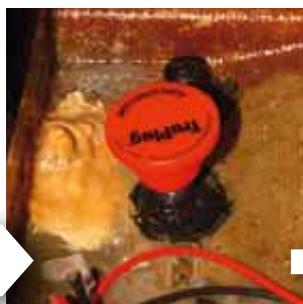
*With a damaged log pipe, the TruPlug formed a perfect seal and stopped the leak completely*

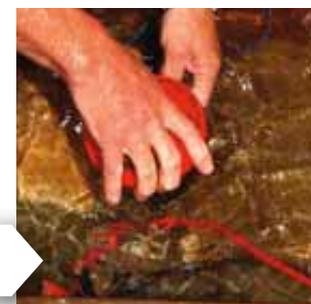
*With the fitting knocked away the TruPlug also formed a perfect seal, stopping the leak*

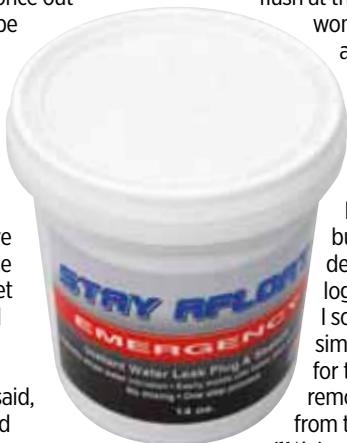
This by-product of petroleum production is described as a 'mouldable polymer'. When cold, it's similar to tepid wax in texture and, once out of the pot, can be worked fairly easily in the hand. I used this in the previous Crash Test to seal the 2mm (1/16in) holes we had drilled in the hull to fix a sheet of thin plywood over a big hole – and it worked perfectly. That said, a screw hole and a 40mm (1½in) seacock tailpipe are very different beasts.

After a couple of seconds spent scooping out enough of the gunge to stuff into the hole, I smeared the brown ball over the tail pipe and the flow stopped immediately. The advantage of this material over a soft wood bung is that it's amorphous, so it doesn't matter how distorted the tail

pipe is, nor do you need to force it into the pipe, which could damage it further.

*ABOVE RIGHT: Faced with a serious leak, I stuck the pot over it, twisted and it sealed perfectly*

*RIGHT: Stay Afloat also sealed the cracked tailpipe, adapting to its irregular shape with ease*

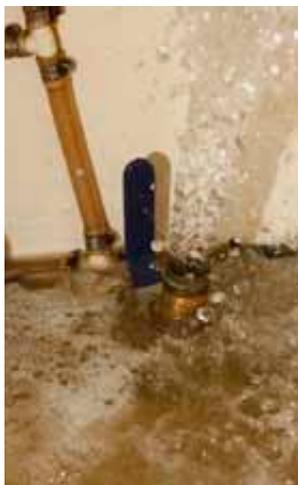
*ABOVE: We removed the galley sink drain pipe and opened the seacock to create a gusher*

There wasn't much water pressure at the heads outlet, but we'd already destroyed the log pipe so I sought out a similar challenge for the gunk. We removed the hose from the 40mm

(1½in) galley sink drain outlet, at the lowest point in the boat and an impressive geyser shot up. This time, I simply upended the pot on the tailpipe, twisted the pot and then lifted it off. Again, the ingress of water stopped completely.

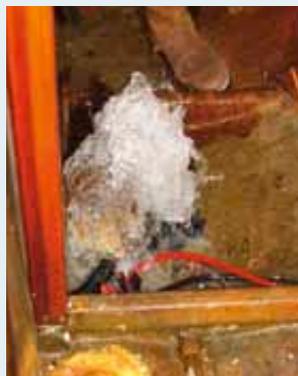
*For our first test, we knocked out the log impeller with a hammer, breaking the fitting*

the fitting with a hammer, tried various methods of stemming the flow, then broke the internal securing nut to remove the fitting completely. We broke the nut, but the mastic used to secure it stopped us removing the fitting entirely. Using a hammer, we reduced it to hull level then tried various ways of stemming the flood.

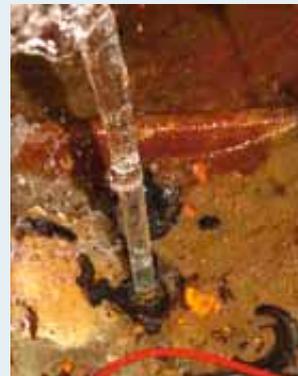
*Next we smashed the fitting away at hull level, leaving a hole that gushed impressively*

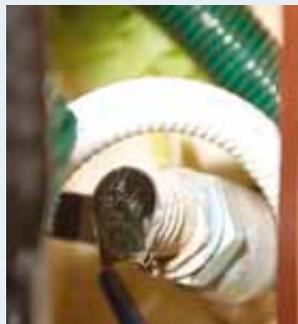
*The cracked toilet outlet tailpipe left an irregular hole to block*

For the second test, Paul removed the hose from the toilet outlet. Though the seacock looked OK, the badly dezincified tail pipe split. A second problem was that the Crash Test Boat has lost weight recently, so the outlet was above the waterline. To ensure we got some flow, we removed the bungs in the two drain holes and flooded the boat to an inch over the sole boards, then asked the travel hoist operator to raise the stern and roll her slightly to port to get the outlet under the water. Once we had flow, we started the test.

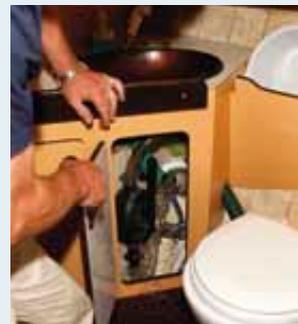
*Access to seacocks can be bad so expect to work one-handed*

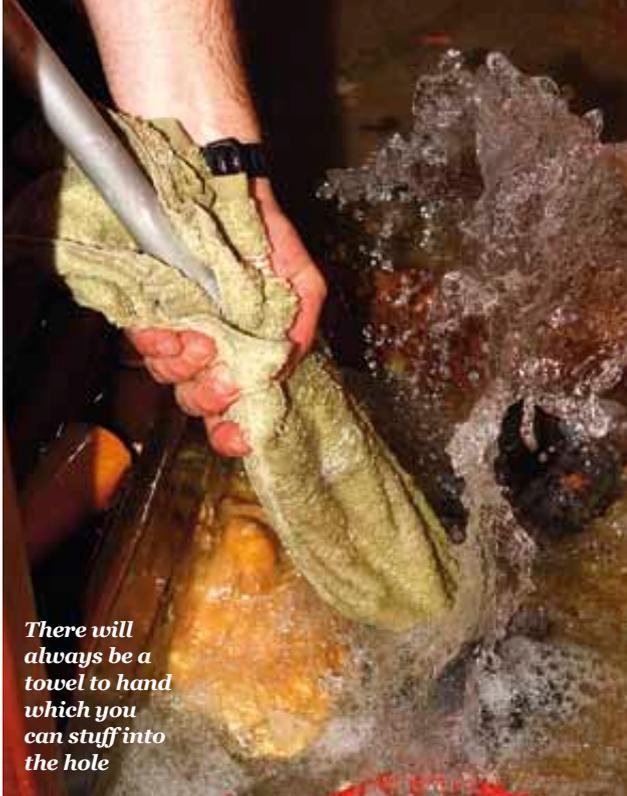
*There will always be a towel to hand which you can stuff into the hole*

*The towel stayed in place but it's a very temporary solution*

On finding a broken seacock or transducer, your first reaction would be to try and stop the spurting water with your hand – and that's a perfectly valid and effective first response, but it does rather limit your movement! We looked around the heads for something we could use to stem the flow other than a hand, and found a towel. We needed something to poke it into the hole with and that could have been a toothbrush or loo brush handle. We happened to have half of our broken bathhook from a previous test nearby, so we used that to stuff the towel into the log pipe.

satisfactory. The flood of water stopped almost completely, which would restore your movement and buy you enough time to work out a better temporary repair. Obviously, within a minute or two the towel would become soaked and could well have succumbed to the water pressure and been pushed out of the hole. Having used it to shove the towel into the pipe, we removed the bathhook but, as Paul pointed out, it could just as well be braced and left in place, improving the security of the repair. Greasing the towel would have improved the effectiveness of this method.

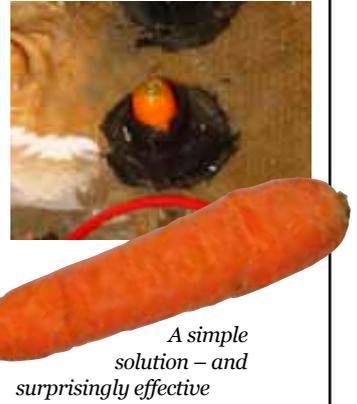
*A simple solution – and surprisingly effective*

We used the carrot in the log pipe and it stemmed the flow perfectly. Unfortunately, despite being a decent size, we couldn't retrieve it from the pipe and it was destroyed in the process of breaking the log pipe down to hull level. I have no doubt, however, that 'nature's

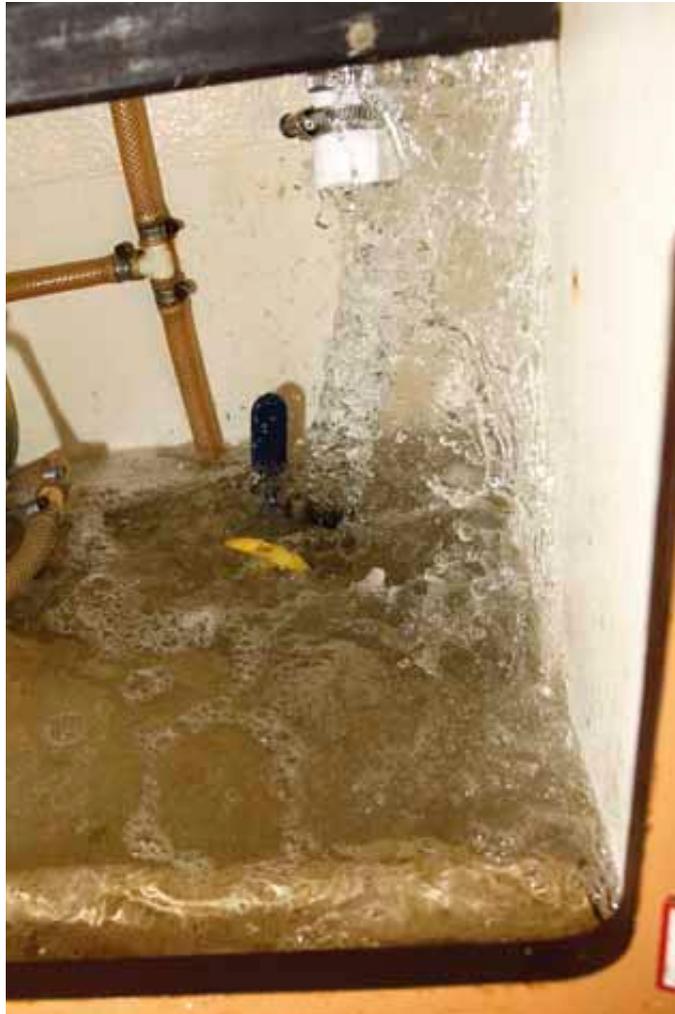
ABOVE: First you have to track down the location of the leak

When you see the sole boards floating and the cabin awash, heave-to and get your crew to man the manual bilge pump. Next, check the water is salt and not from a fresh water tank failure – it would need to be a very large water tank to float the sole. Then check all your seacocks, ideally starting with the largest. Work out in advance which is the quickest

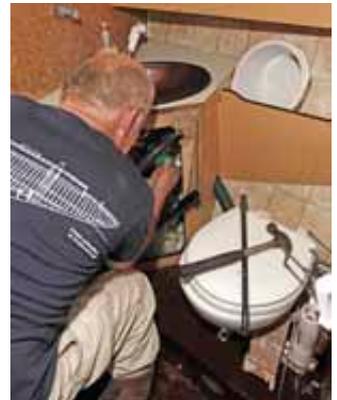
ABOVE: Paul tried to refit the outlet hose, but it wouldn't fit

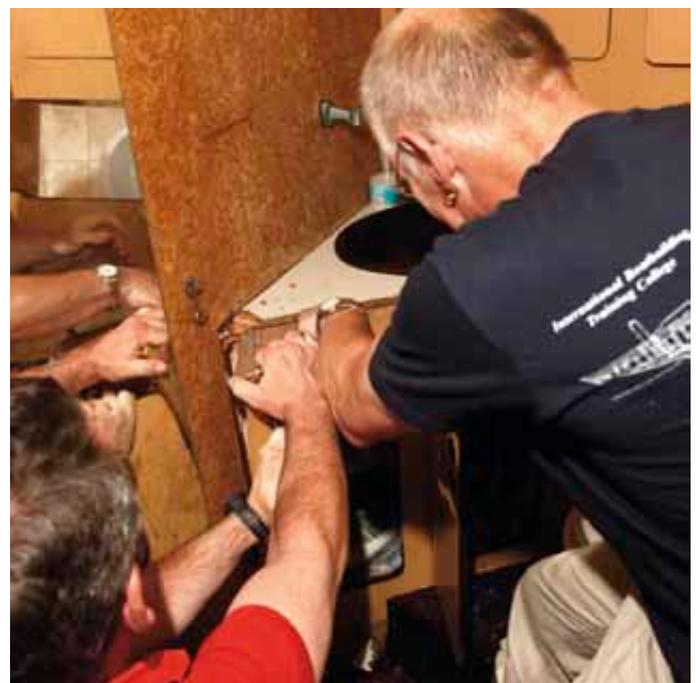
New boats have FRP mouldings, but even ply joinery wouldn't strip away

below the sink in the forward heads, so Paul tried to strip out the plywood sink unit with a hammer and a crowbar – it would be a tougher FRP moulding on newer boats – but after a minute, he had only removed the fascia.
